FERRALERT™ F.I.L.M.

FERROMAGNETIC INCIDENT LOG MANAGER

FERRALERT™ D.A.T.A.

DATA ANALYSIS and TRACKING APPLICATION

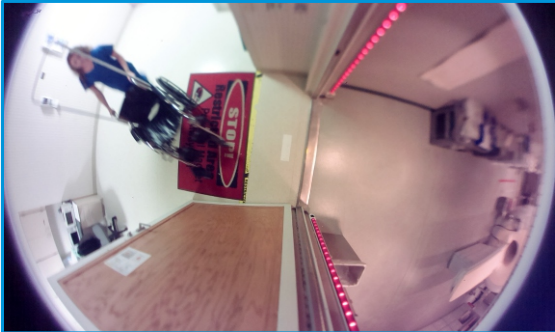
Visual Advance Pre-warning:

All 48 red alarm lights of FerrAlert™ HALO II PLUS are activated on the approach of a ferromagnetic wheelchair WELL OUTSIDE scanner room. No Audio alarm sounds at this time.

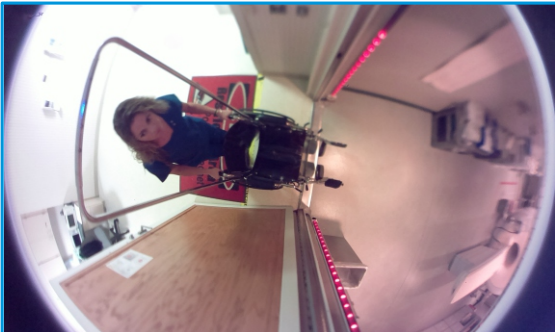
Audio alarm and F.I.L.M. are activated:

When the Photoelectric sensor of the FerrAlert™ HALO II PLUS is crossed, the *F.I.L.M.* stores the images that lead up to the activation. *F.I.L.M.* continues to take and store images after the incident occurs to document actions after the incident.

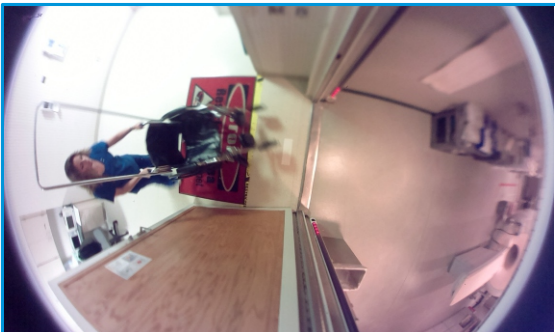
Location of the projectile threat pinpointed:

In this image, both bottom sensors are activated indicating that the area of the threat is near the floor and ferromagnetic. The location feature allows determination of the position of ferromagnetic objects for post incident data analysis.

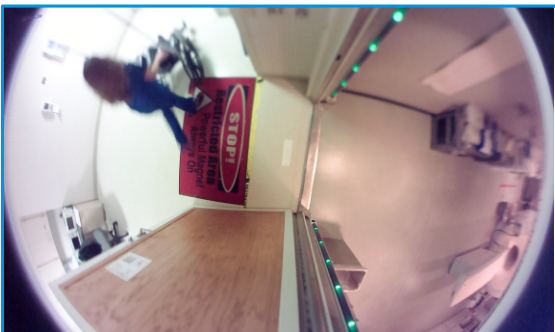
Action taken after incident:

The person did not continue into the scanner room, but instead turned around and left the area. The green READY lights illuminate indicating that there is no approaching ferromagnetic threat.
